Daimler Light 15 1936

By Andy Lockwood.

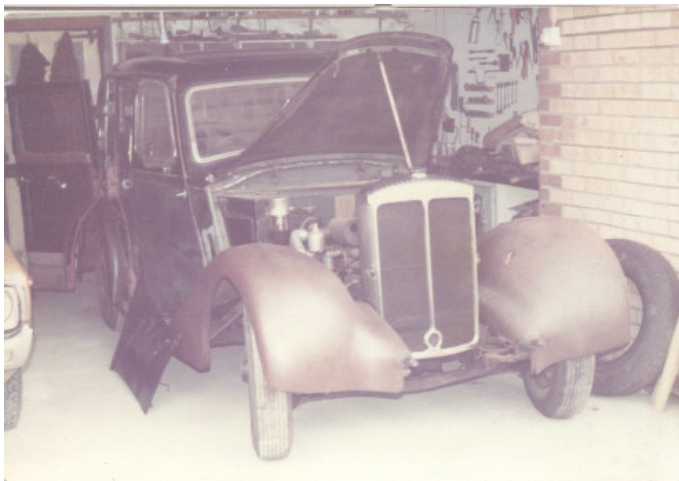
The car as it arrived home — note the rust coated wings, these were removed and taken for shot blasting followed by etching primer as soon as possible.

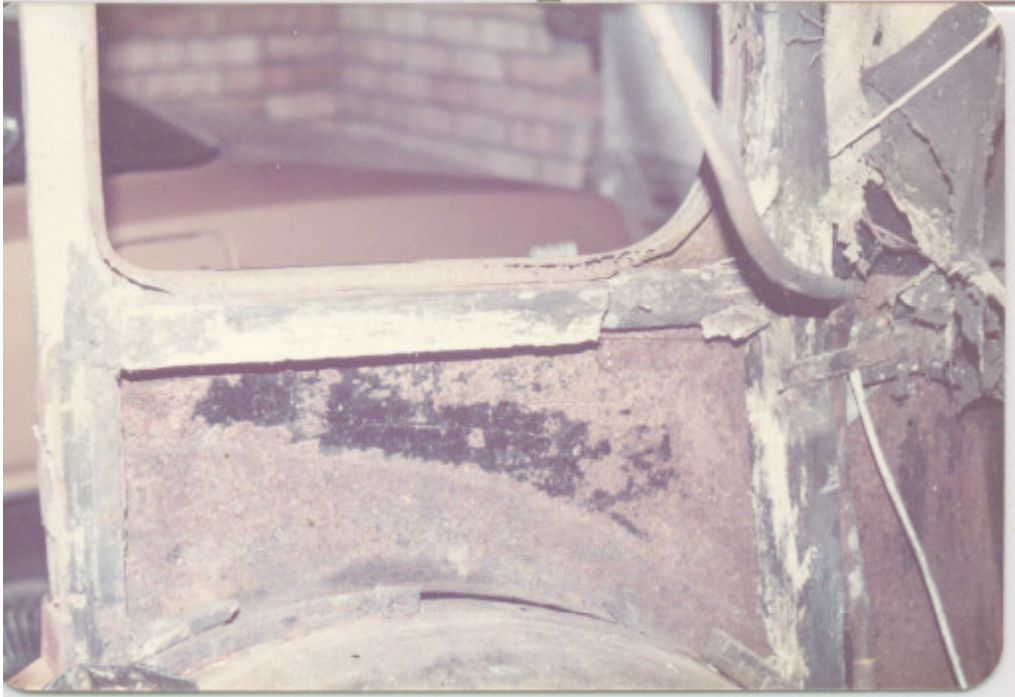
With the interior removed it was clear that the ash frame had suffered where the sliding roof drain tubes had perished and allowed rainwater to stream inside, all the joints in the frame are half let, glued and screwed.

The picture below shows how the right hand rear corner of the ash frame had suffered, Once the loose crumbling remains of the lower section had been cleaned out there was nothing left of the curved section, which the outer wings screw to from the underside.

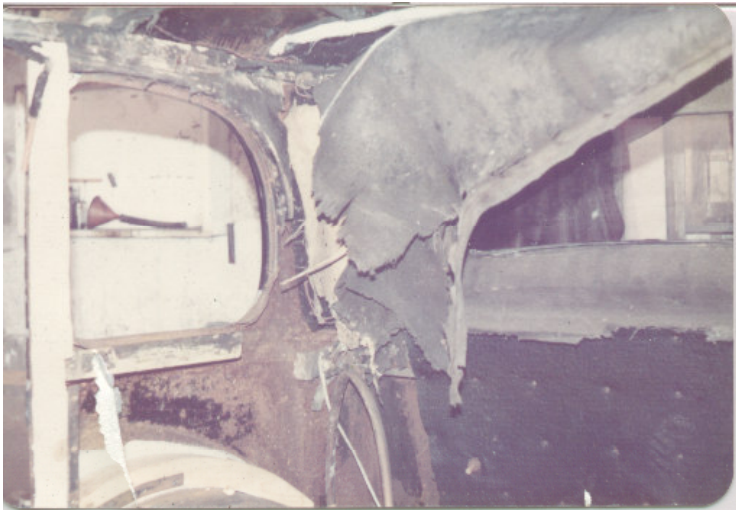
You can see on this picture that the curved section round the inner wheel arch and the upright which carries the rear door hinges have been replaced and some of the old wood around the side window has been removed, the body panelling is steel

I understand that coach builders never used mortise and tendon joints as they worked loose and tended to be create noise as the vehicle moved, this meant that it was possible to remove and replace one piece of wood at a time without dismantling the whole structure, we came across a large plank of ash in a disused joiners shop, (it may well have been left over from some cart shafts judging by the shape) templates were

made for the curved sections and a friend cut these out on his band saw.

which was nailed to the ash frame in panels then its joints welded so the outer metal is quite strong in its self. All the new joints were glued and screwed using waterproof glue and plated screws.
