## AUSTIN HEALEY SPRITE MKI (FROG EYE) REBUILD CARRIED OUT DURING THE 1990s

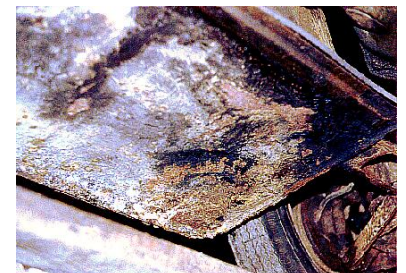
To the right is a view looking at the underside of the foot well, it had large flat plates tacked / bolted underneath and on top to form a sandwich with the fuel and brake pipes trapped in the middle.

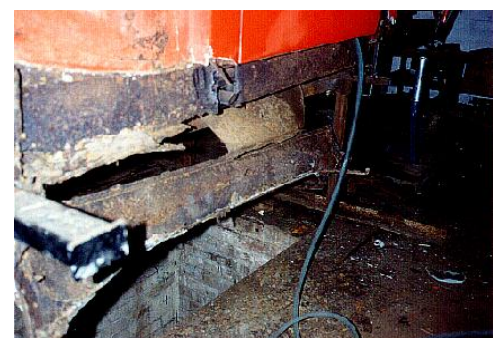
rear bulkhead to meet up with the new sections, finally the stiffening sections were added and all joints fully welded, the picture to the left shows the almost completed near side spring box, while the picture below shows the new floor.

could be removed later) The off side was left in tact at this stage as it was the strongest side. The bottom edges of the A and B posts and bulkheads were all cleaned up, the new floor was tacked in place followed by the inner and outer sills, the remains of the rear suspension box was removed, the new rear spring mounting box was positioned on e the new floor and welded in place at the bottom, a repair section was made up and fitted into the

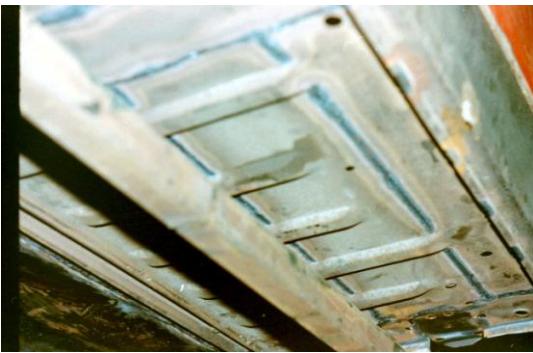
Once the near side was completed the same procedure was carried out on the off side, the picture to the right shows where the new floor and sill

met up with what remained of the front wheel arch and bulkhead.

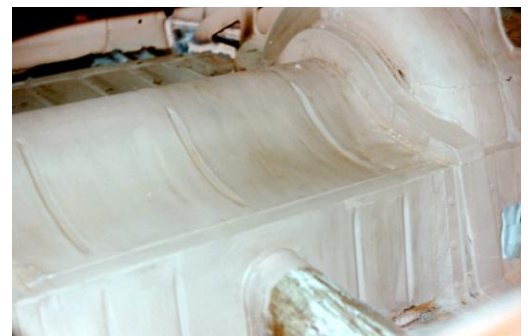
Small repair sections were made up and welded in where required, once all was fully welded top and bottom the stays were removed, the floor of the boot area was good apart from the lower rear section, as it is so difficult to access

we opted to cut out the old lower floor and replace it with a new panel -- removing all the old under seal was a struggle to say the least.

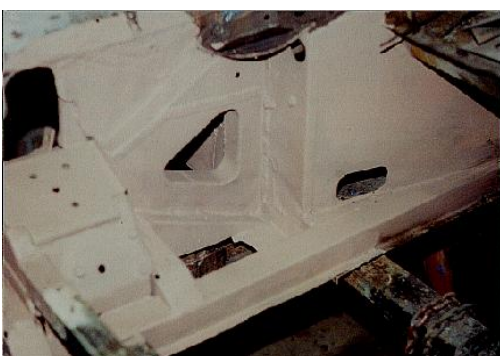
The inner wing sections had rotted in the triangle sections where road dirt had collected, rotten bits were cut out and replaced, the open area was also plated in to form a box section. The underside of the front cross member had been

dented in at sometime in its life, part of the flat under section was cut out and a new piece welded in.
