Daimler Light 15 1936

By Andy Lockwood.

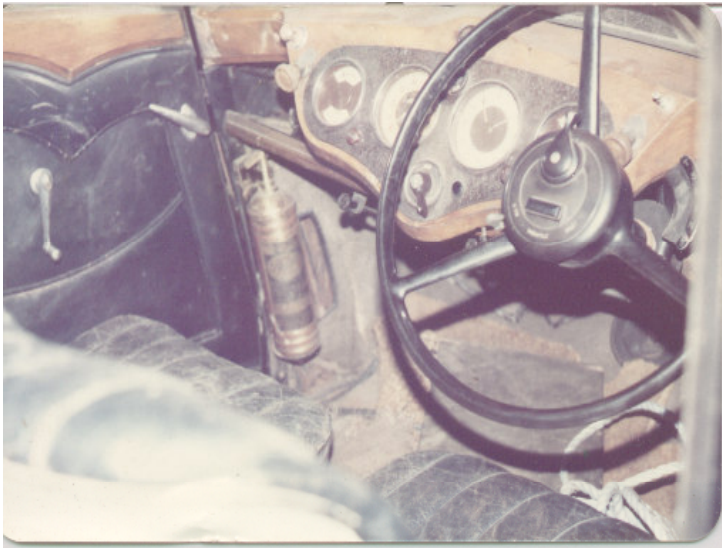
Carpet also covered the bottom section of each door panel, this was quite handy as the bottom section of each plywood backed panel was rotten but the higher up leather section was in quite good condition, so the bottom section of each panel was cut off and sanded to a tapered edge, this meant that matching sections could be cut from new marine ply and have their mating edges

tapered to glue in place with waterproof glue, this was then covered by bound carpet.

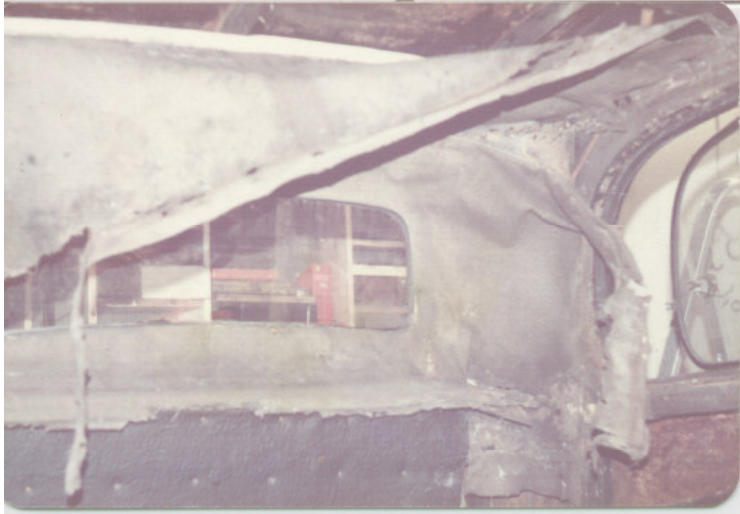
You can see on this picture that the curved section round the inner wheel arch and the upright which carries the rear door hinges have been replaced and some of the old wood around the side window has been removed, the body panelling is steel

which was nailed to the ash frame in panels then its joints welded so the outer metal is quite strong in its self. All the new joints were glued and screwed using waterproof glue and plated screws.

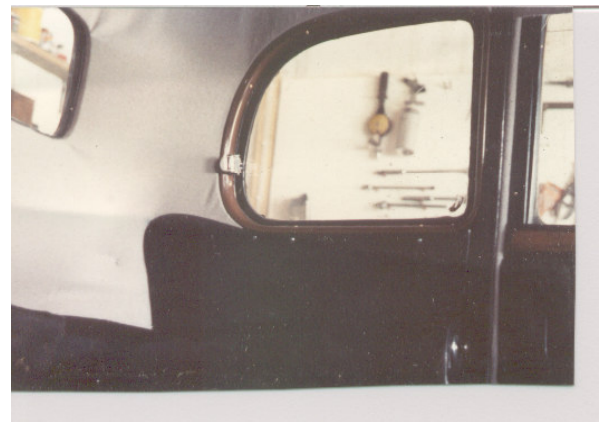
All the old side panels and shelf were in a very poor state so these were used as templates to make new ones from marine ply, which was covered in blue vinyl before being screwed into place in the same way as the old ones.
