## AUSTIN HEALEY SPRITE MKI (FROG EYE) REBUILD CARRIED OUT DURING THE 1990s

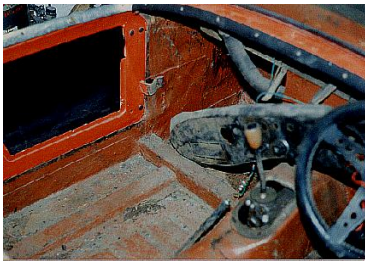
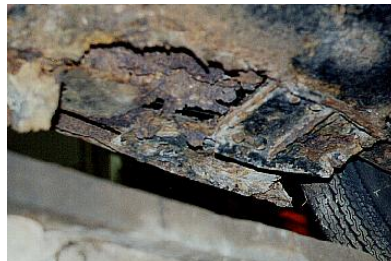
The car was owned by a friend who had it stored for a few years, when I first looked at it, the bonnet off and stored separate, the shell was complete with a free turning engine that looked correct, the doors opened and shut ok, the floor looked to consist of one patch on top of another, the boxes that hold the quarter elliptic rear springs were well rotted though still holding together, a bump in the area of the rear number plate had caused the rear boot section to bulge, the bonnet was solid but slightly miss shaped due to rot in the underside stiffening.

Once the car was in the workshop and the mechanical parts removed, the extent of the work required

became clearer, in reality the lower 6" of the body were needing replacement with the exception of the centre tunnel.

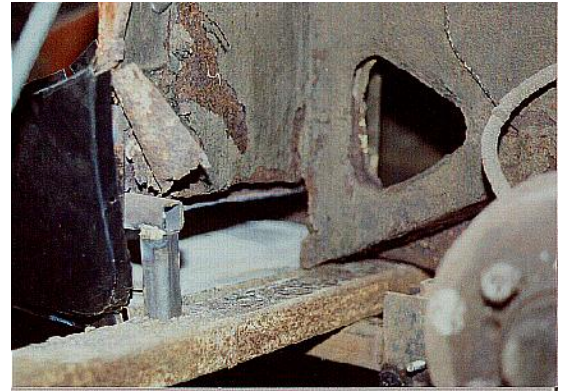
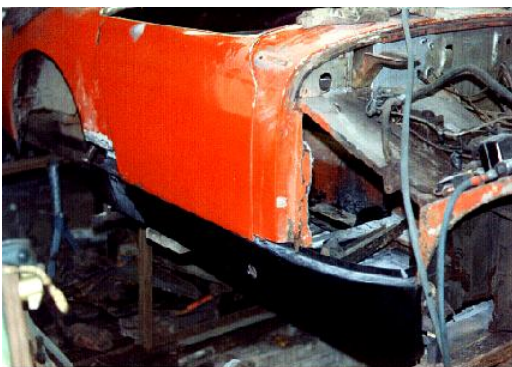
Once the near side was completed the same procedure was carried out on the off side, the picture to the right shows where the new floor and sill

met up with what remained of the front wheel arch and bulkhead.

Small repair sections were made up and welded in where required, once all was fully welded top and bottom the stays were removed, the floor of the boot area was good apart from the lower rear section, as it is so difficult to access
