Morris 1000 Exhaust Replacement

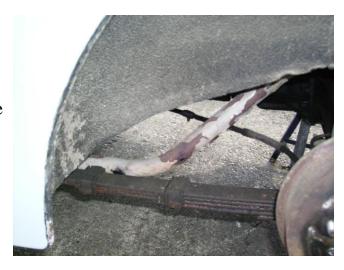
Removing the old one was easy once the manifold clamp was undone, it was that rotten that it could be snapped in three with almost no effort.

Thankfully the brass manifold clamp nuts came unscrewed easily and the clamp could be cleaned up and reused.

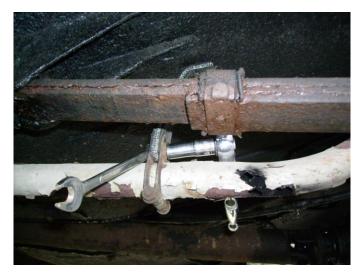
The centre and rear clamps also came off without too much effort so they could also be reused after a good clean with a wire brush, the centre support is close to the forward end of the rear spring hanger.

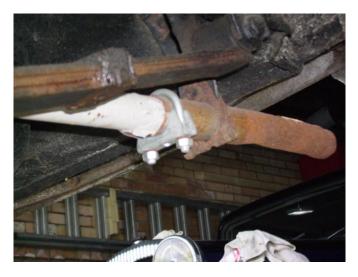
The rear support bracket is close to the near side rear spring rear hanger

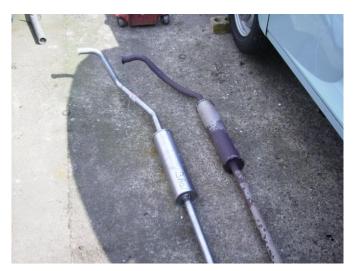
Comparing the old pipe (or at least what remained of it, with the new one, the box was slightly further back and smaller but all the curves were in the correct places.

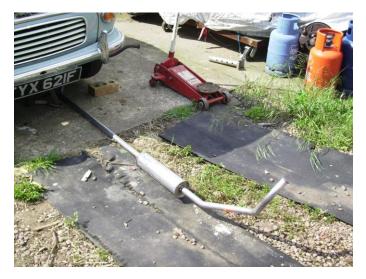
I was working on the concrete drive with no pit or other access, in the back of my mind I felt sure that I had fitted one before in the same position some 25 years ago.

My concern was that I could not recall how to get the curved section of the rear exhaust pipe over the rear axle, I tried the thread it over from the front but it would just hit the boot floor, no matter what angle I directed it from.

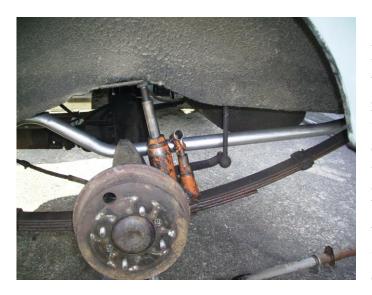
At first I thought it was due to the fact that the car was not lifted high enough, but the more I thought about it I realised that no matter how high the car was lifted it would not make the axle clearance any greater. I thought back to the days when dad fitted them on a 4 post ramp and remembered him putting a small jack between the spring and the bump stop and applying just enough weight to gain a couple of inches extra clearance.

With that extra bit of clearance between the rear axle and the body, the new exhaust could easily be threaded over, taking care not to puncture the fuel tank, once in place it was just a case of hanging it on its supports and securing the manifold end with the clamp once a smear of exhaust sealer had been applied to the flange faces.

Once the car was back on its wheels the engine was started and the joint was checked for leaks.
